# Innovation at Work in Corrosive Environments

Linus Mazeika, 3L&T Inc., USA, presents the company's latest anti-corrosion coating.

CorrosionGard™-160SH2, can be used in ducts, fans, chimneys and baghouse filters.

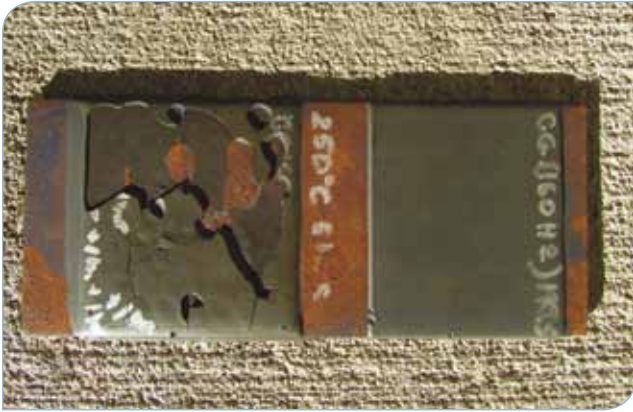
Figure 1. Heating to 250 °C for 5 hours.

To compare the high temperature performance, a test plate was coated with both materials and exposed to 250 °C for 5 hours. Figure 1 shows the previous CorrosionGard™-160S severely damaged while the new CorrosionGard™-160SH2 is in perfect condition.

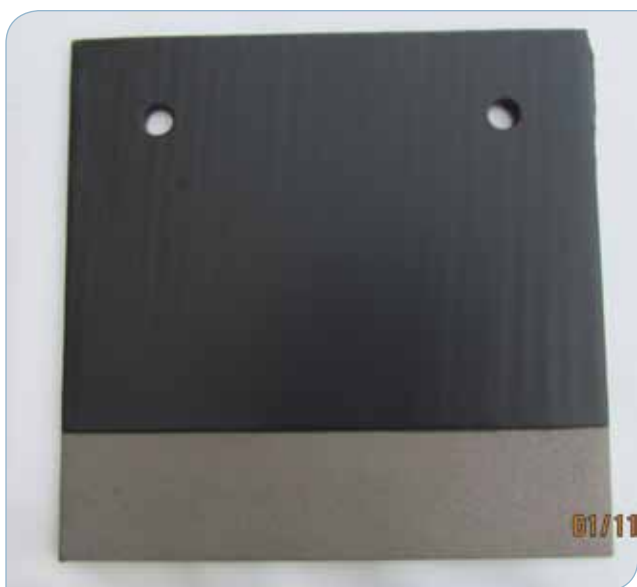
**Figure 3.** New test plate coated with CorrosionGard™ 160SH2.

Another coated test plate was exposed to UV light and sprayed every other day with a salt solution and a sulfuric acid solution. This test generates an extremely aggressive corrosive environment. Again the EIS measurements on the new plate and after 1 year of exposure show no measurable difference. Figure 3 shows the test plate new, and Figure 4 shows the same plate a year later. This second test plate's coating is in perfect condition; the exposed metal is badly corroded but corrosion stops right at the edge of the coating. This highlights a unique characteristic of 3L&T's coating materials – their resistance to undercut corrosion. This is a destructive failure mode where an exposed edge starts corroding under the coating and propagates until most of it disbonds and delaminates.

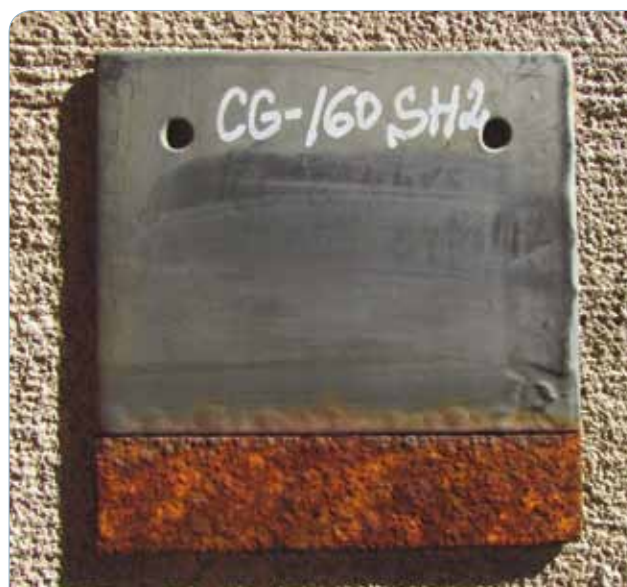
**Figure 4.** Exposed border corroded, no undercut disbondment.

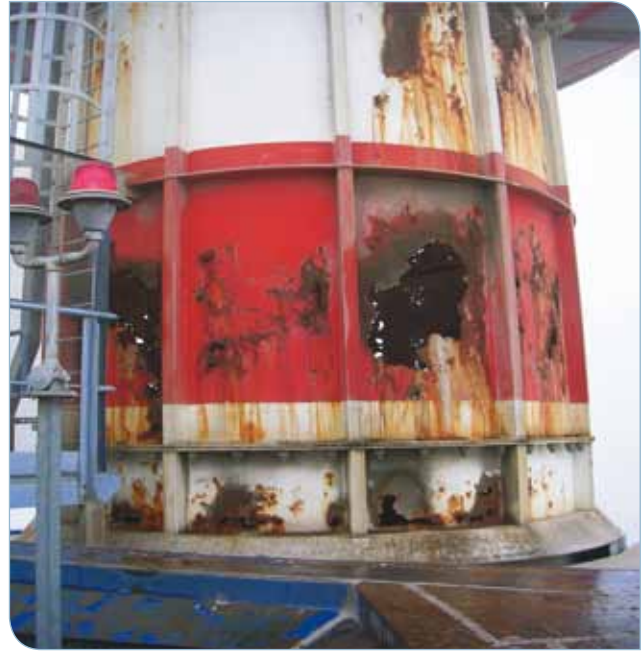
Figure 5. Severely corroded upper section of a stack.

Figure 5 shows a severely corroded chimney in Italy. At this stage, the metal was beyond repair, the damaged section was replaced with a new construction cylinder and coated to protect from future corrosion.
